Inspection Report

CW-20120405-PSI-001

Client Name: XXX Trading	
Product Name: Seamless Carbon steel pipes	
Inspector: Jack Xu	
Report approver: Jason Wan	
Inspection type: PSI	
Inspection location:	CANGZHOU, HEBEI, CHINA
Inspection date:	05/Apr/2012
Your reference number: N/A	
P/O number: HB2011-12-05	
Buyers: XXX Trading	
Supplier: Heibei XXX Steel Pipe Manufacturing Corporation	
Order quantity:	2607.8m/221pcs
Pcs ready for inspection:	141pcs
Reference sample available:	N/A

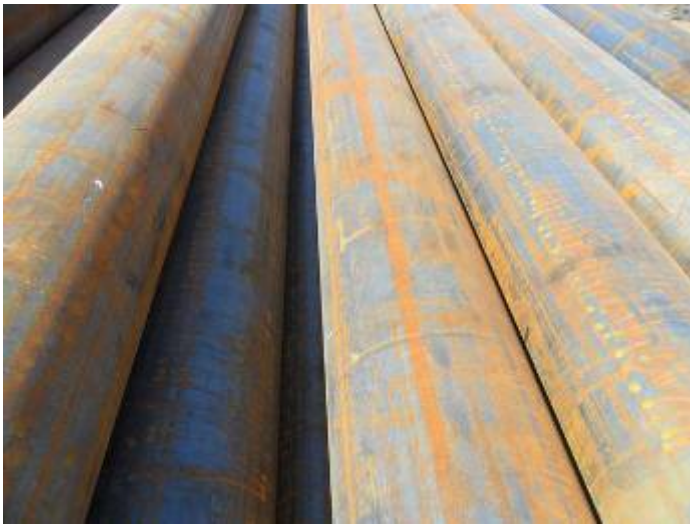
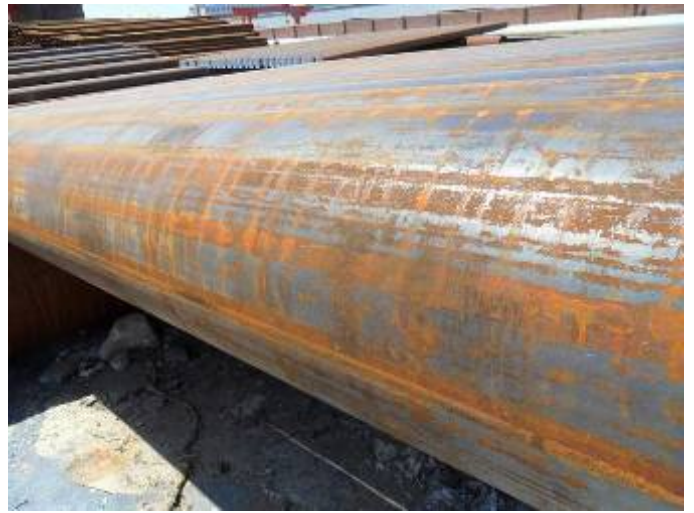
The products were placed the outdoor position. Found the product surface still had obviouse rust due to the rain at outdoor.

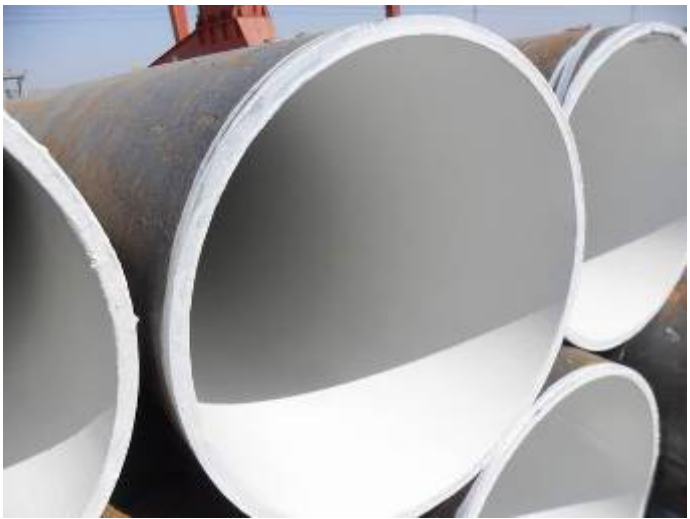
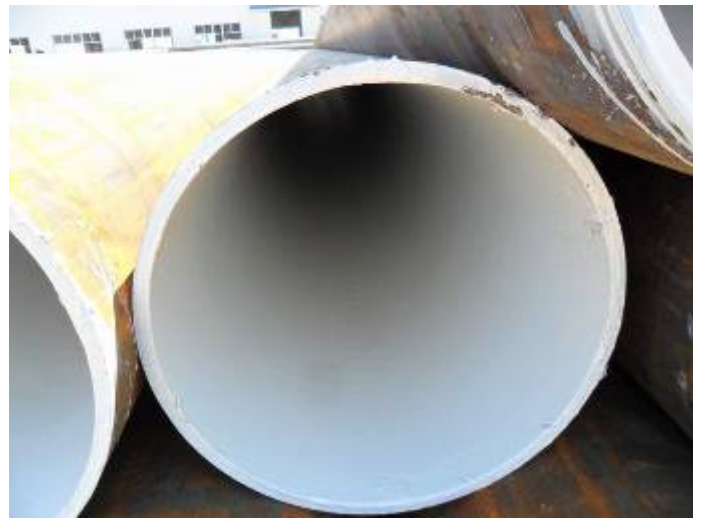
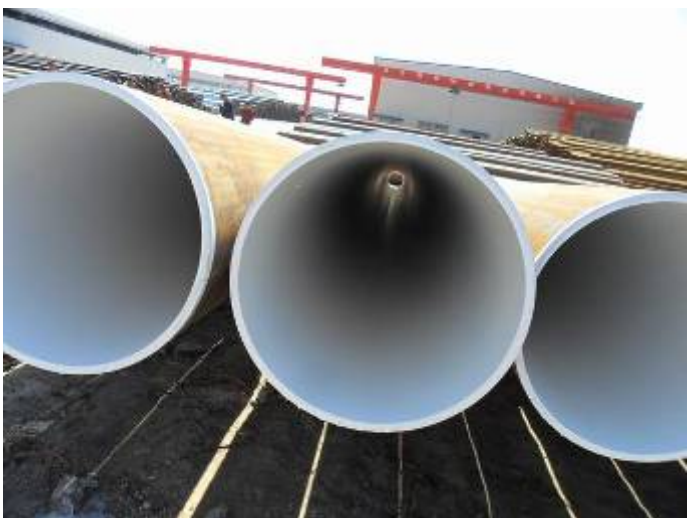
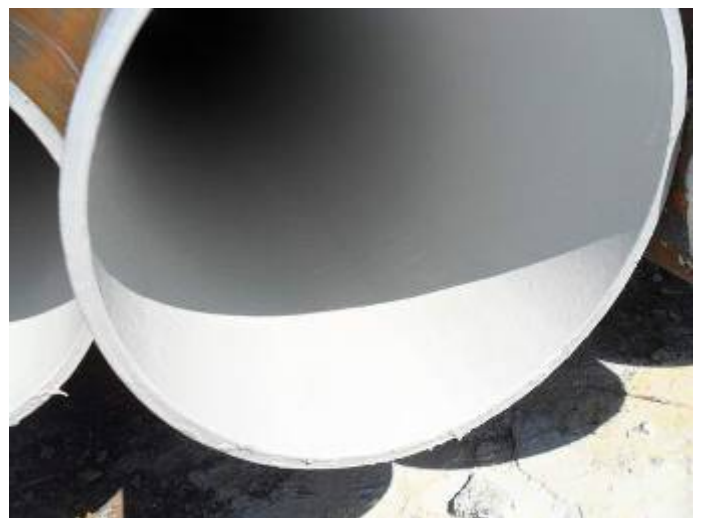
Confirm it is plain on ends of pipe. Confirm the factory had cleared the sharp burr on the ends.

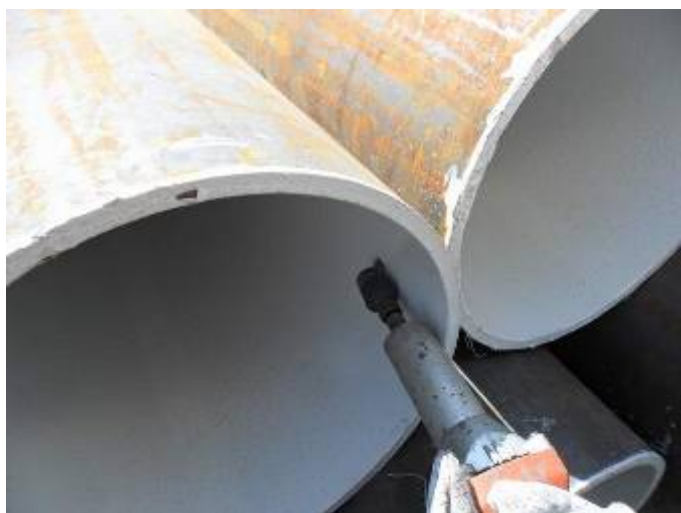
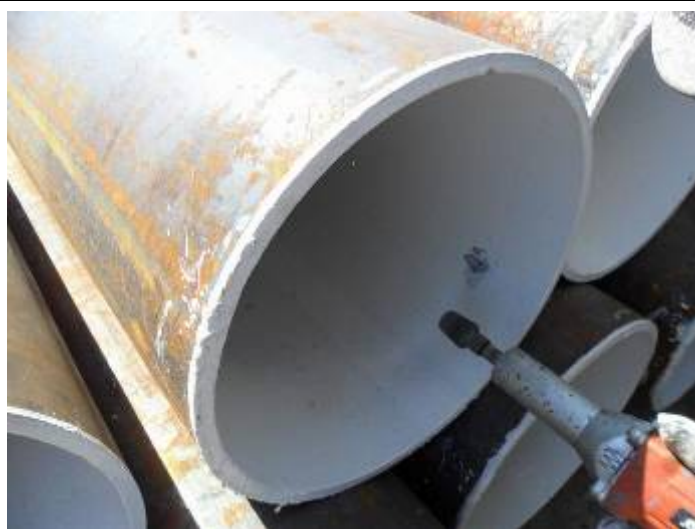
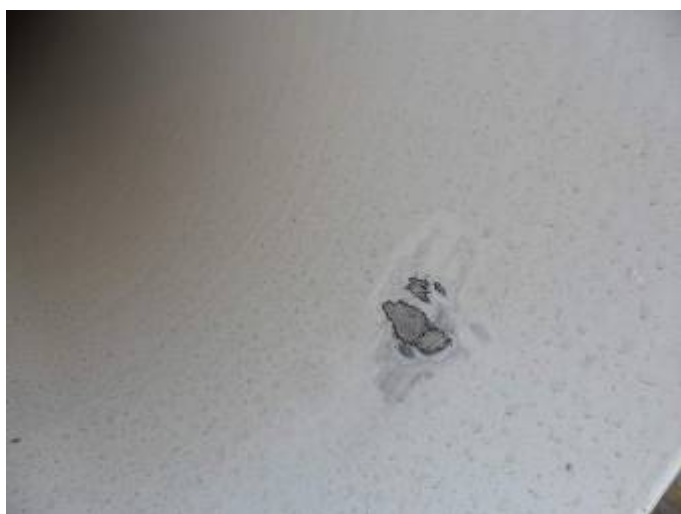
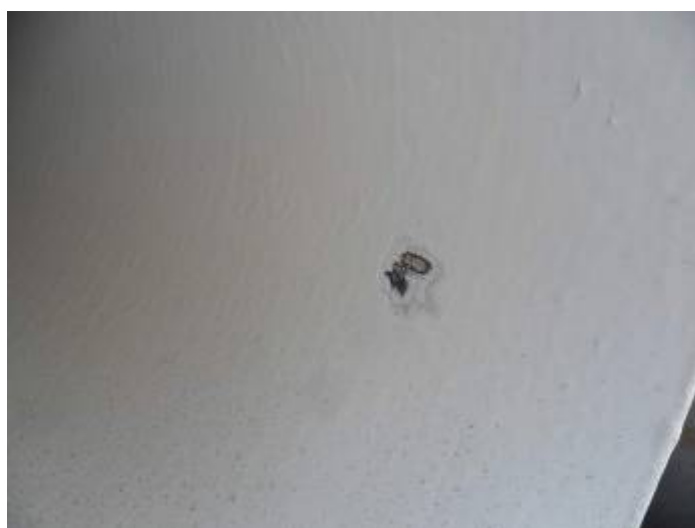
Checked the inside surface by wiping off epoxy resin paint. Confirmed the factory had clear the oxide films before the inside surface was coated the epoxy resin paint.

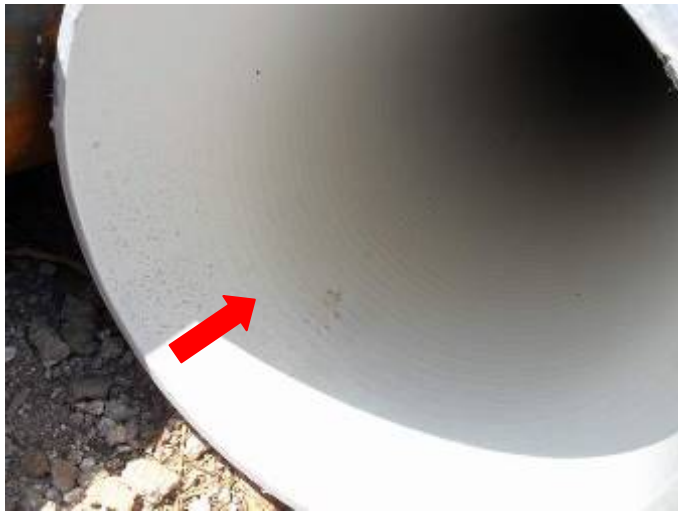
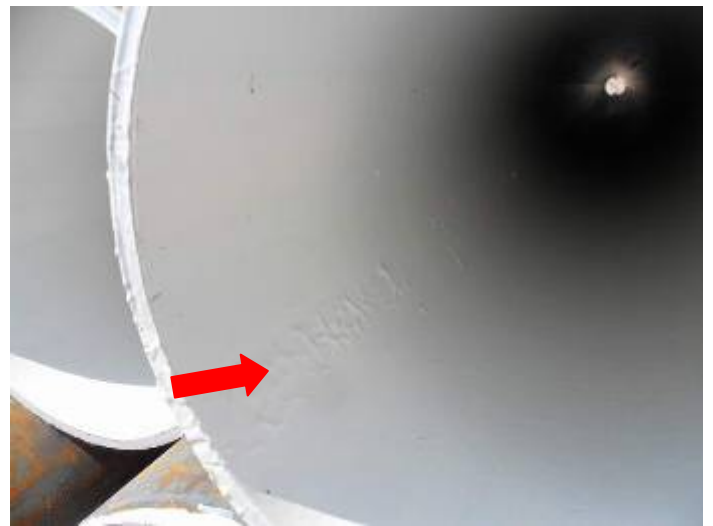
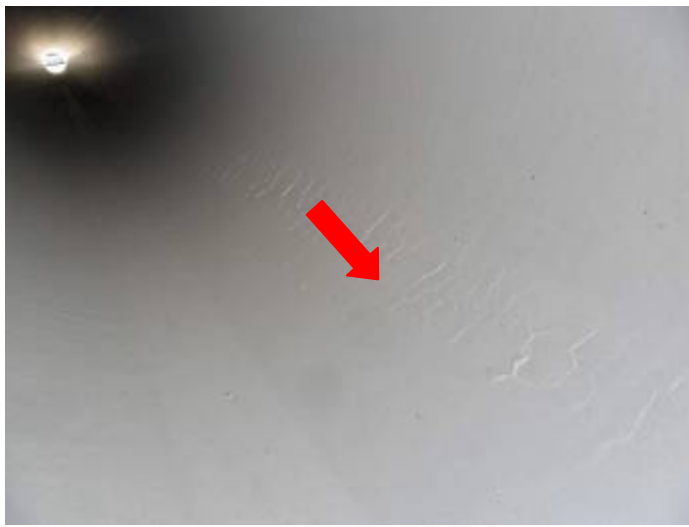
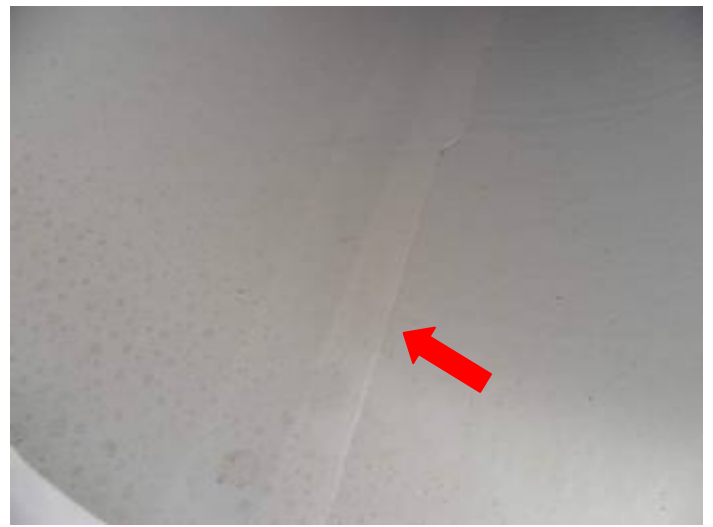
26 pcs out of 141pcs(about 20%) were found that poor epoxy resin paint coating inside surface. Have required the factory to wipe off it and re-coat epoxy resin paint inside surface and they factory promised they will fix those well.

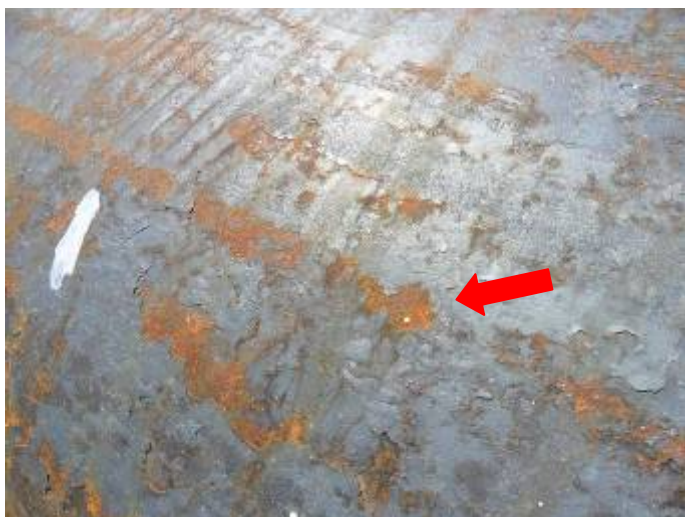
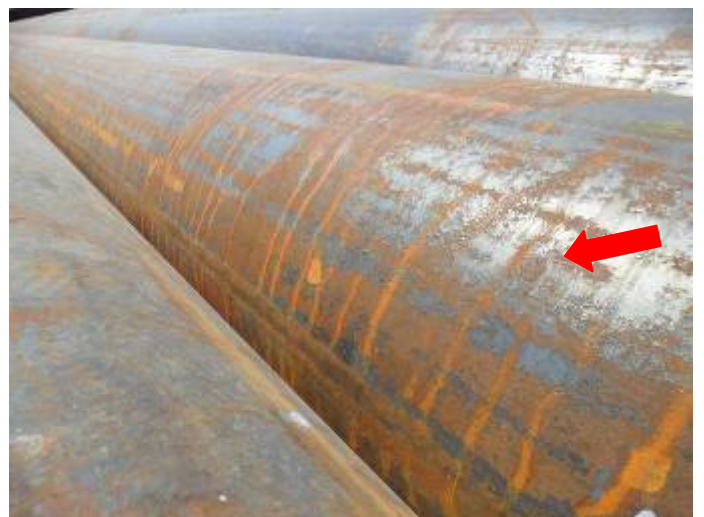
Minor : Few oxide films on outer surface.-2pcs from random 32 samples

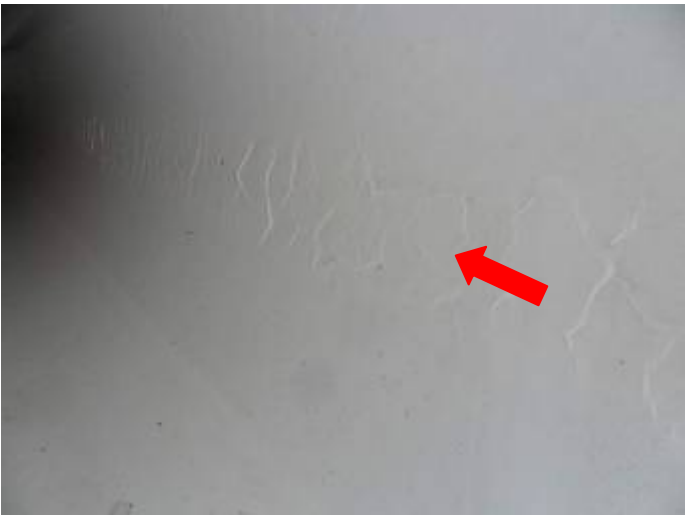
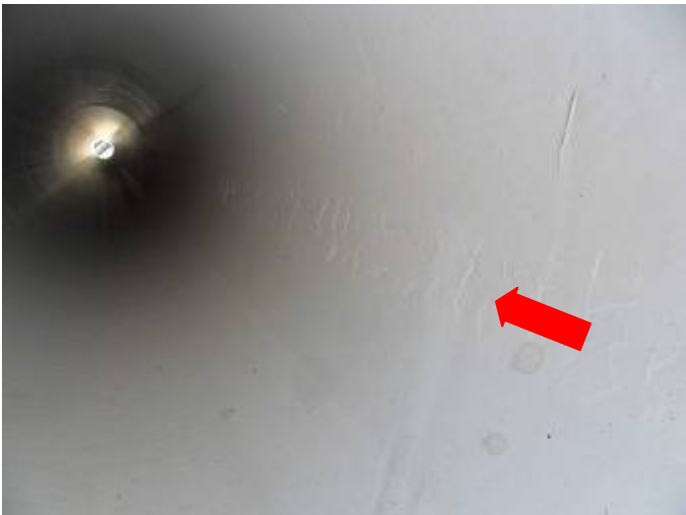
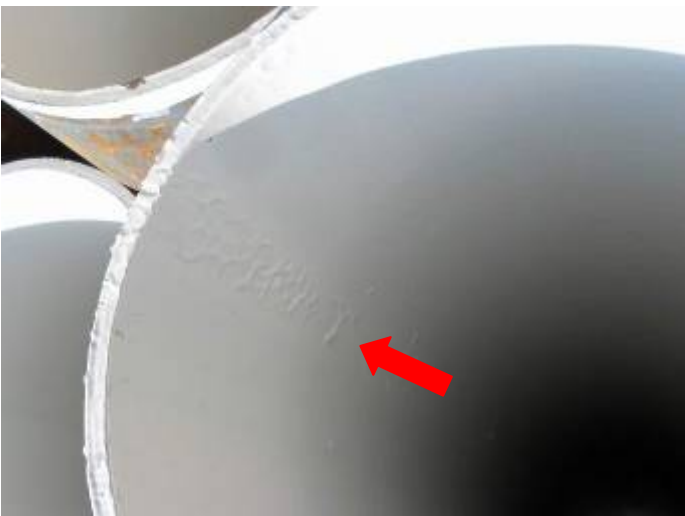
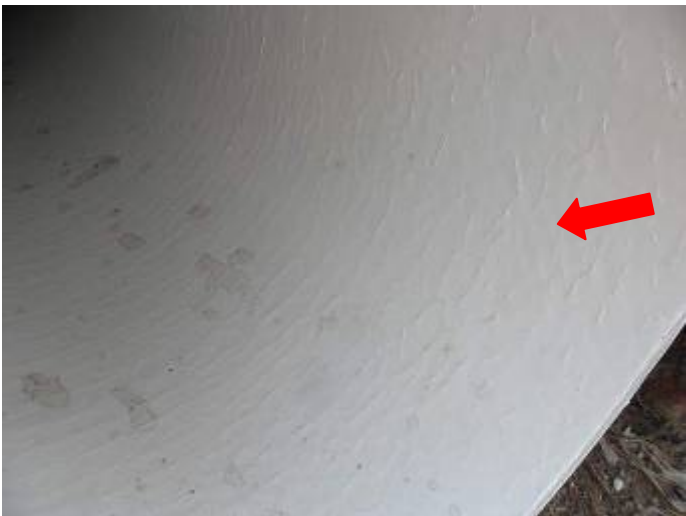
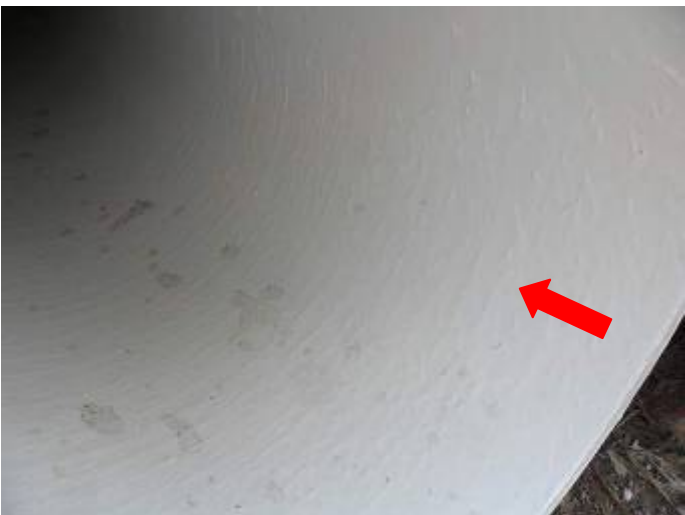
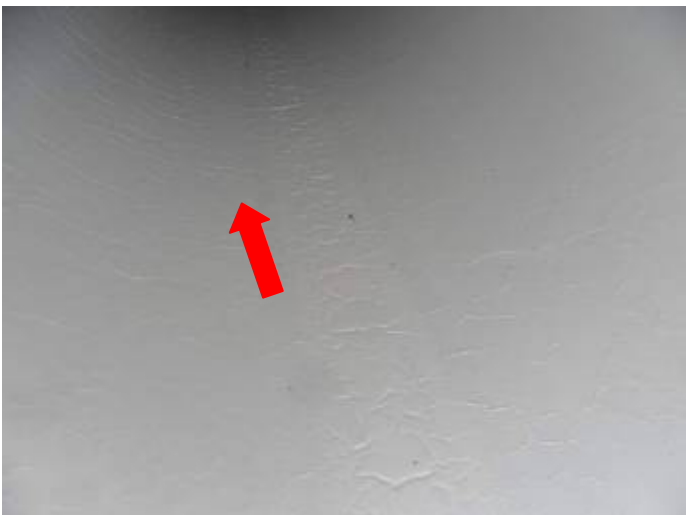
Minor : Poor epoxy resin paint coating on inside surface.-6pcs from random 32 samples.(Please refer to the Important Remark 3 above)

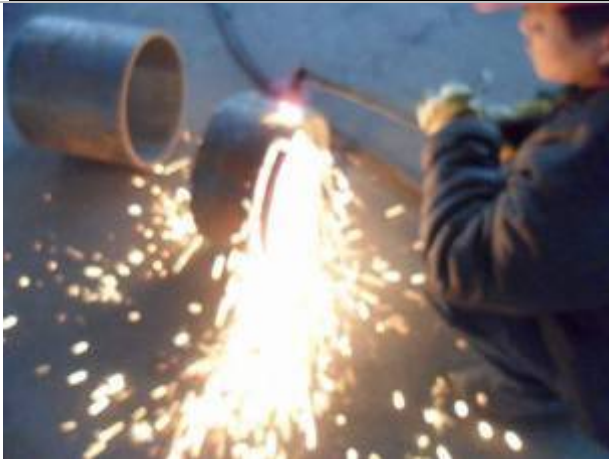
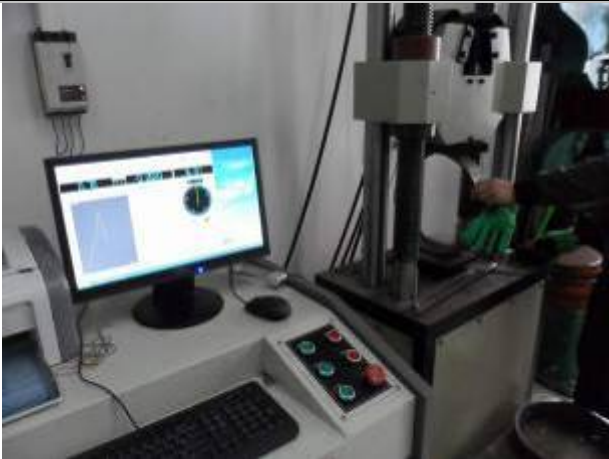
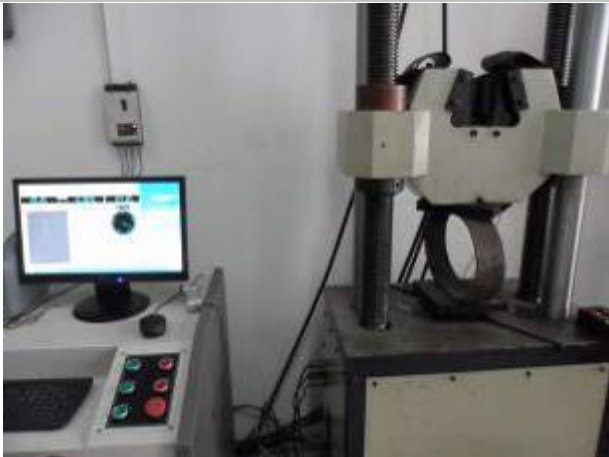
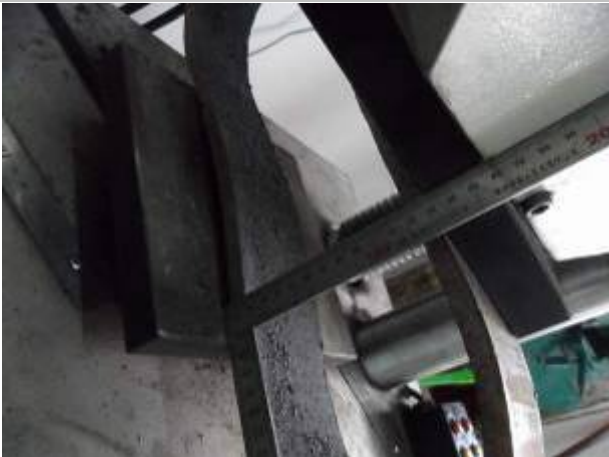
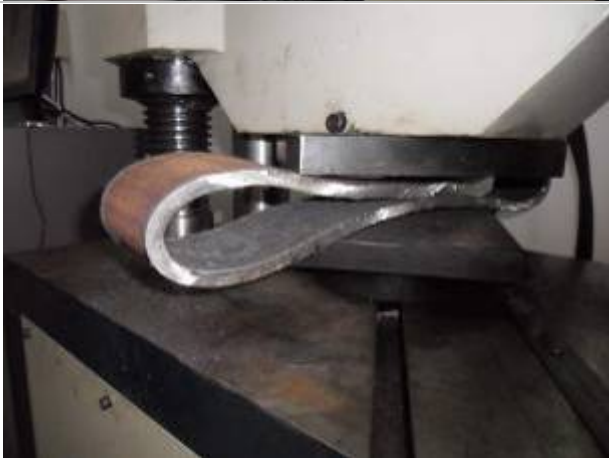
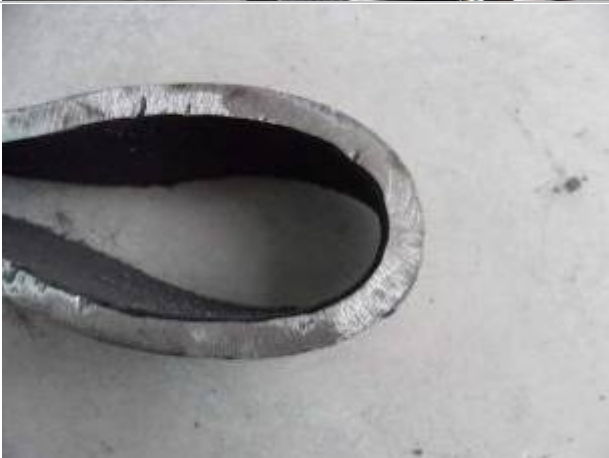
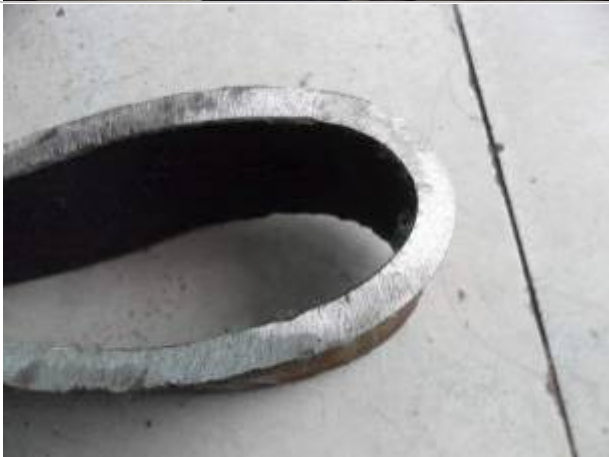
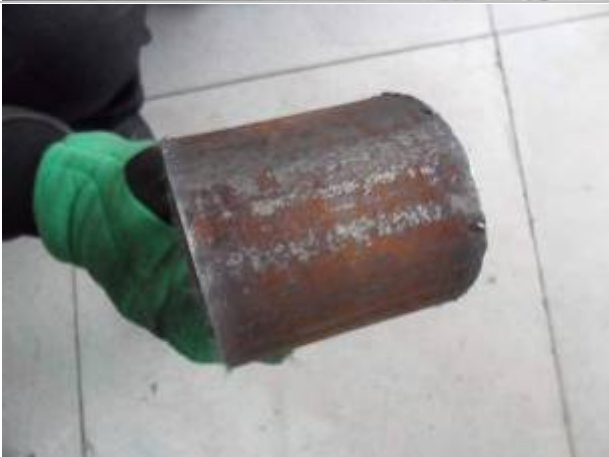
2. Product Flattening Test: -2 pcs

Confirm without developing cracks

Passed

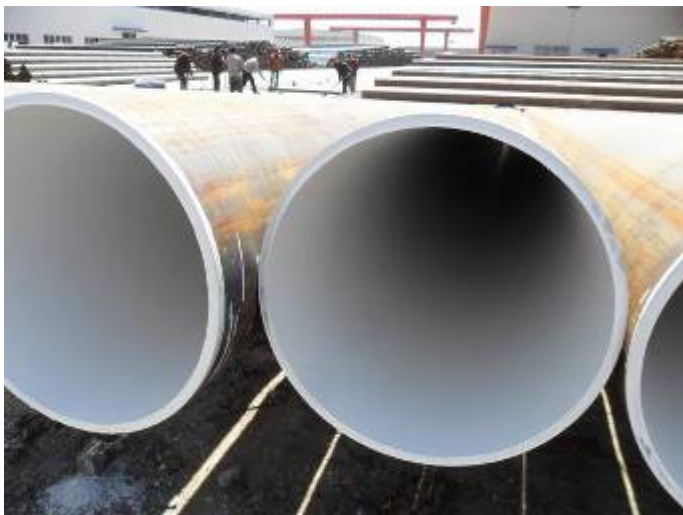
Fine epoxy resin paint coating on inside surface

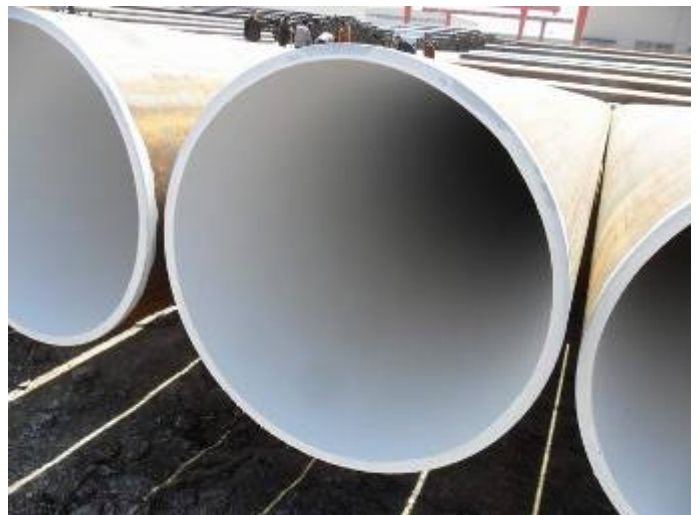
Fine epoxy resin paint coating on inside surface
