Inspection Report

CW-20120405-PSI-001

Client Name: XXX Trading	
Product Name: Seamless Carbon steel pipes	
Inspector: Jack Xu	
Report approver: Jason Wan	
Inspection type: PSI	
Inspection location:	CANGZHOU, HEBEI, CHINA
Inspection date:	05/Apr/2012
Your reference number: N/A	
P/O number: HB2011-12-05	
Buyers: XXX Trading	
Supplier: Heibei XXX Steel Pipe Manufacturing Corporation	
Order quantity:	2607.8m/221pcs
Pcs ready for inspection:	141pcs
Reference sample available:	N/A

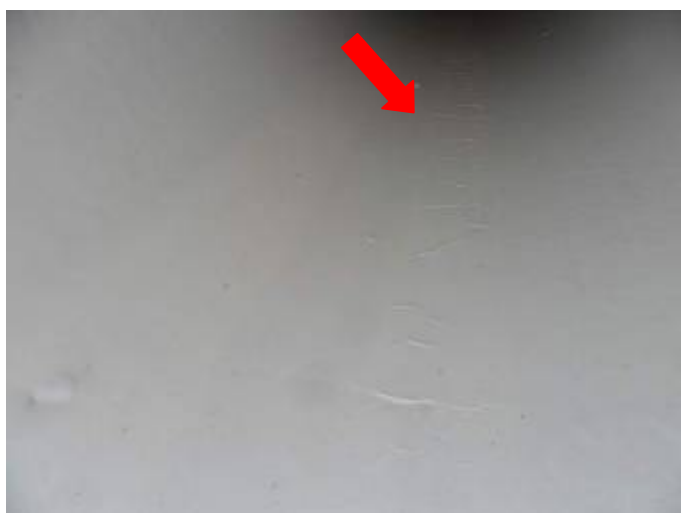
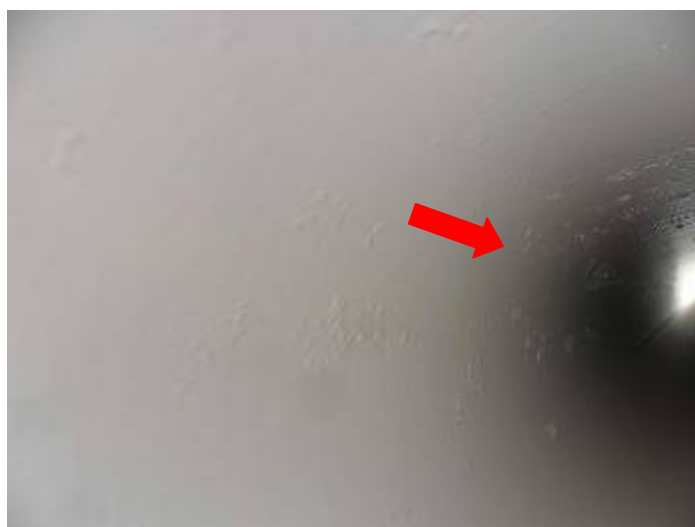
26 pcs out of 141pcs(about 20%) were found that poor epoxy resin paint coating inside surface. Have required the factory to wipe off it and re-coat epoxy resin paint inside surface and they factory promised they will fix those well.

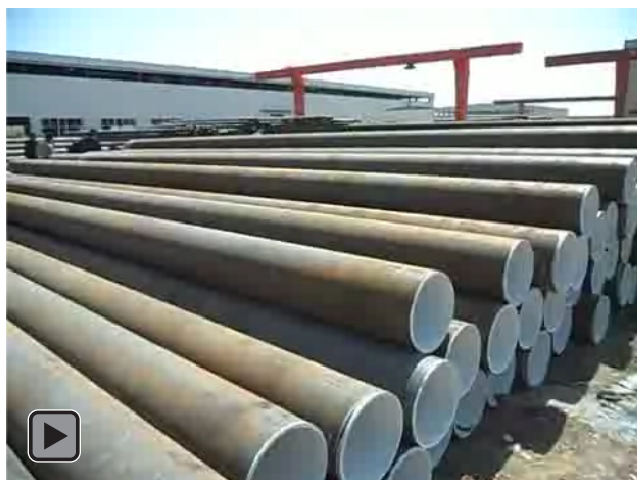
Finished products at outdoor position

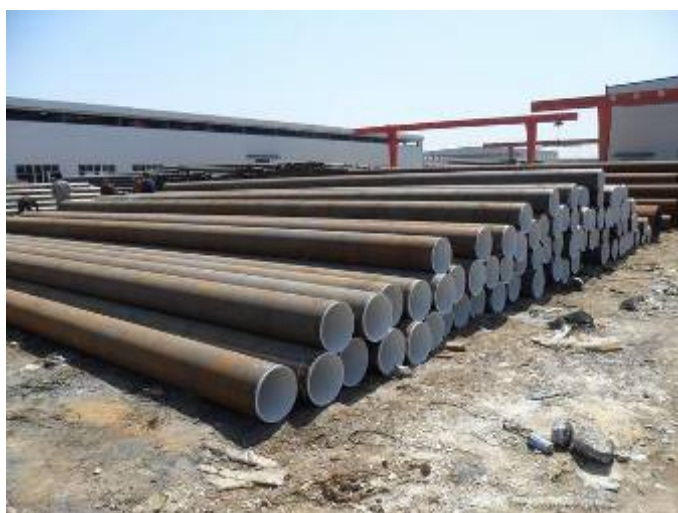
1. Finished products on outdoor

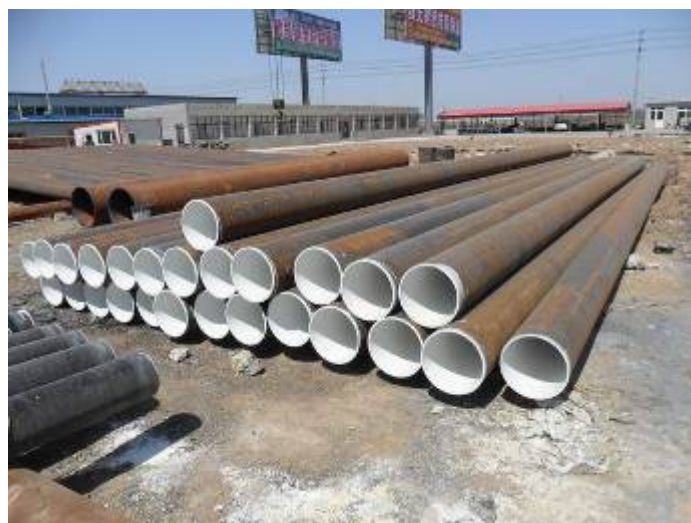
2. Finished products on outdoor

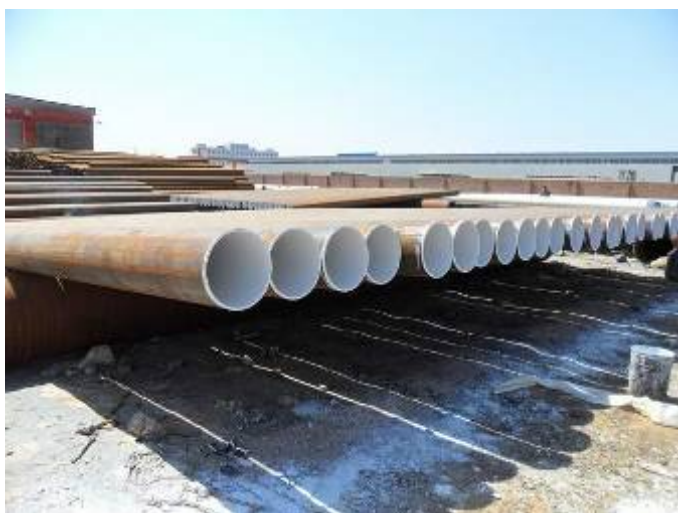
3. Finished products in outdoor

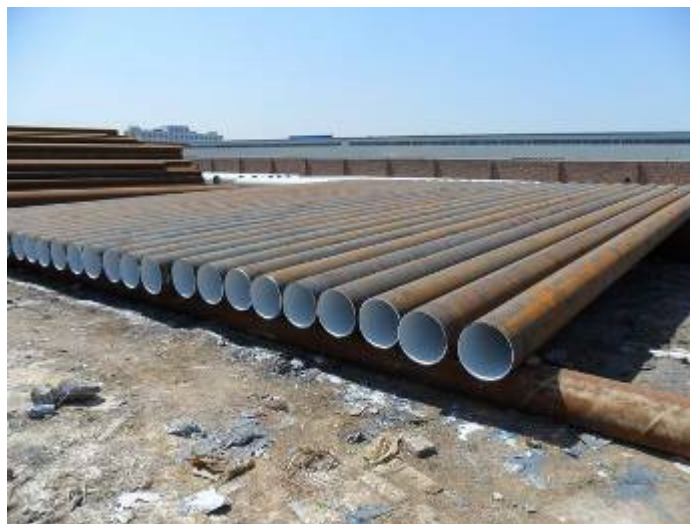
4. Finished products in outdoor

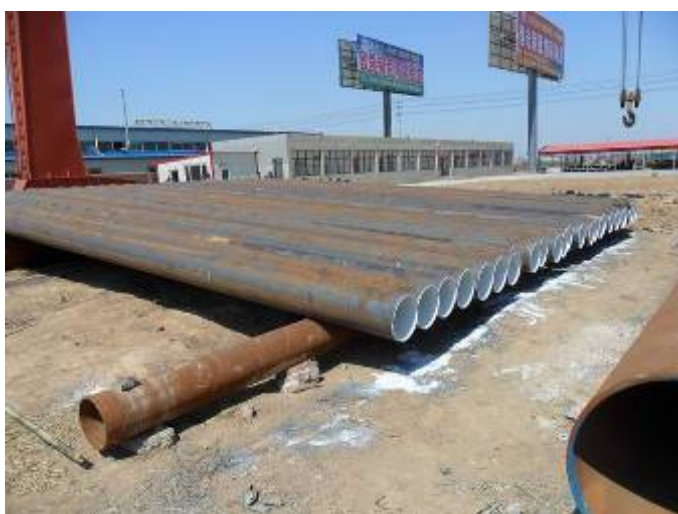
5. Finished products on outdoor

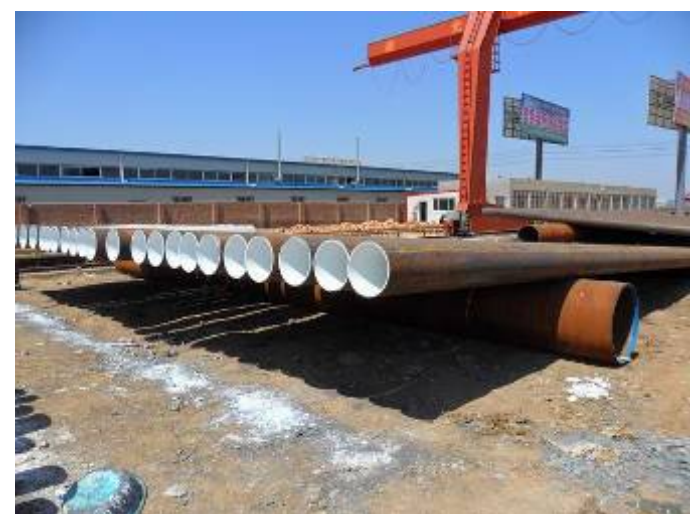
6. Finished products on outdoor

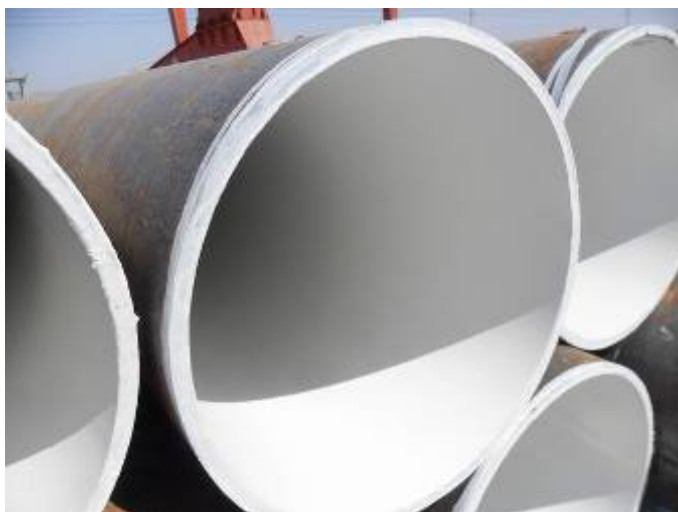
7. Plain ends on both sides

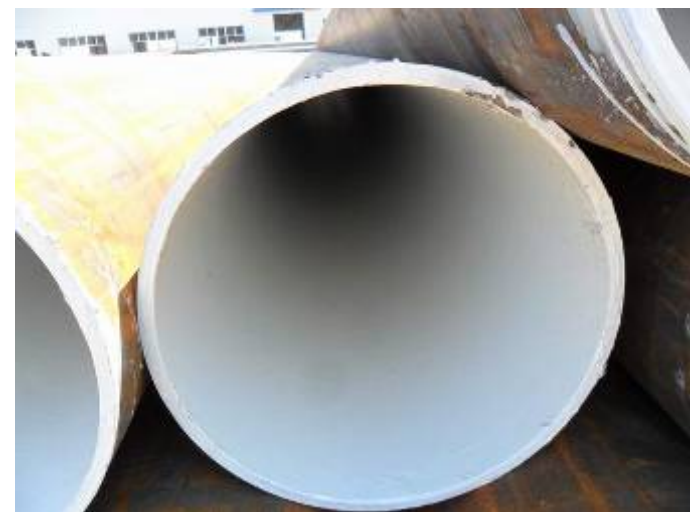
8. Plain ends on both sides

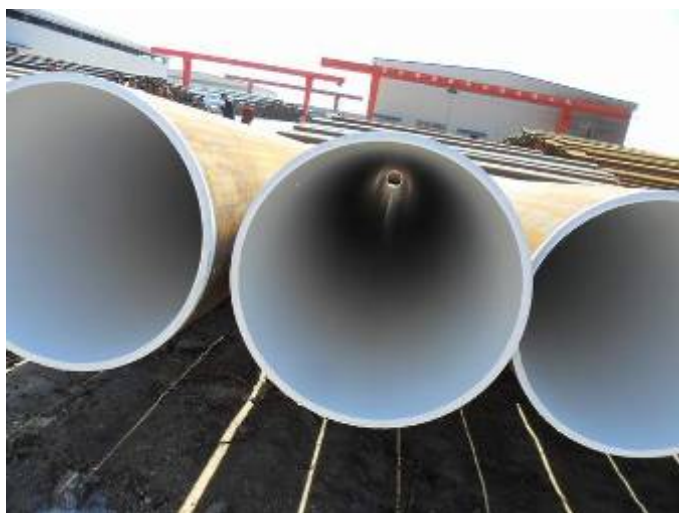
9. Plain ends on both sides

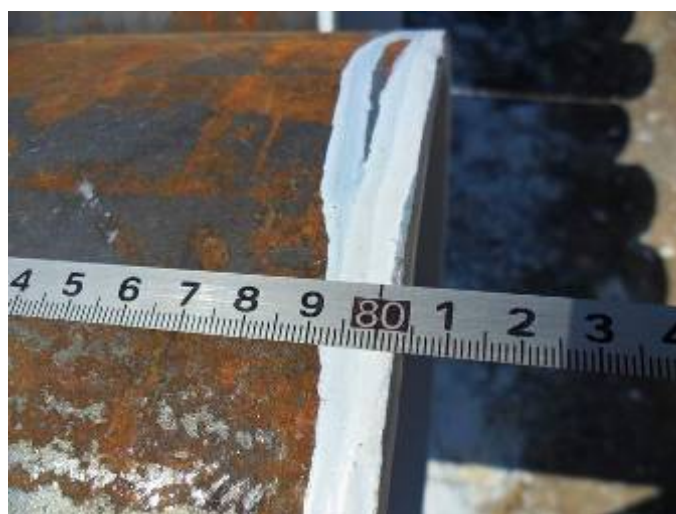
12. Length test: 11803mm

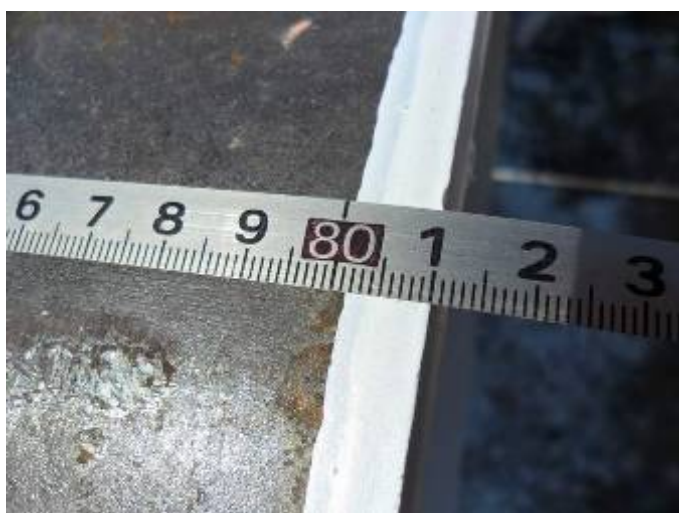
13. Length test : 11810mm

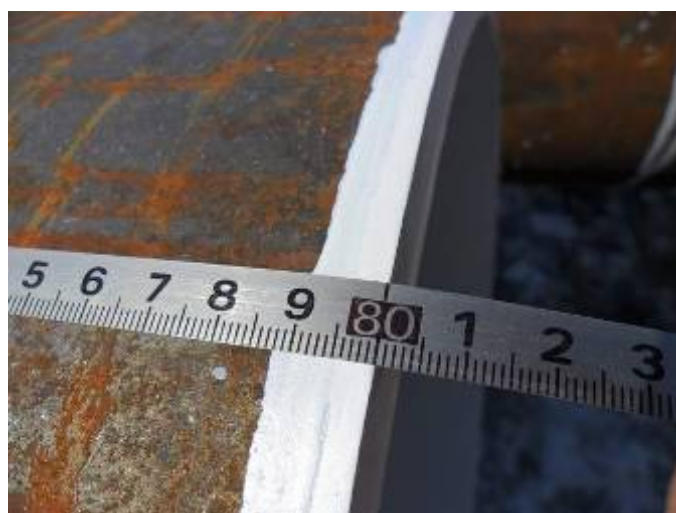
14. Length test : 11800mm

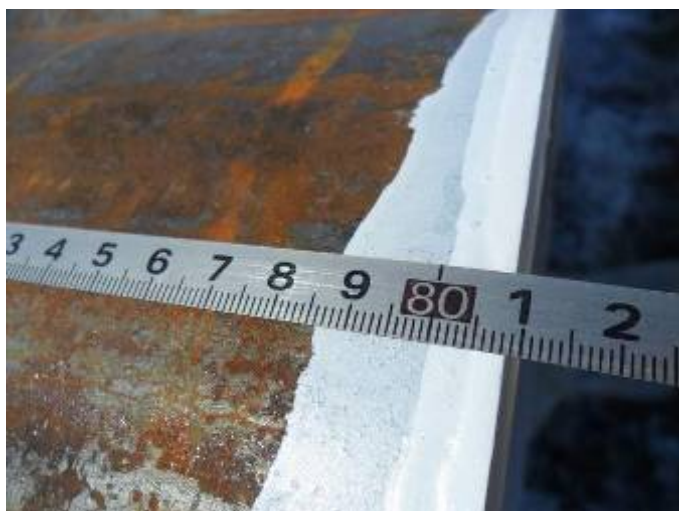
15. Length test : 11808mm

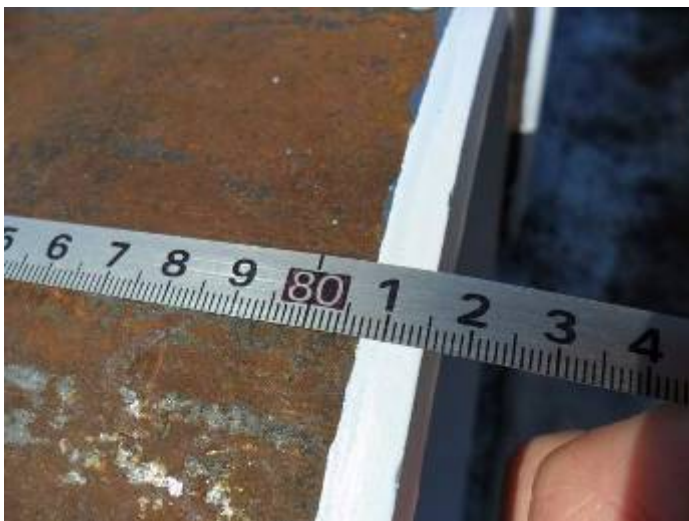
16. Length test : 11814mm

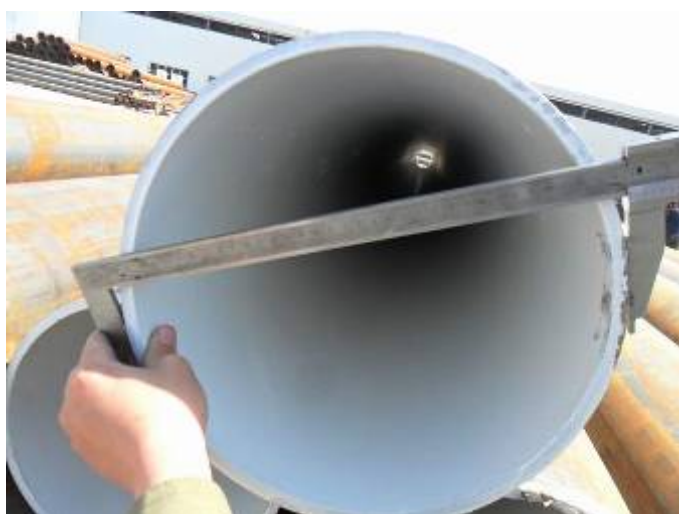
17. Outside diameter

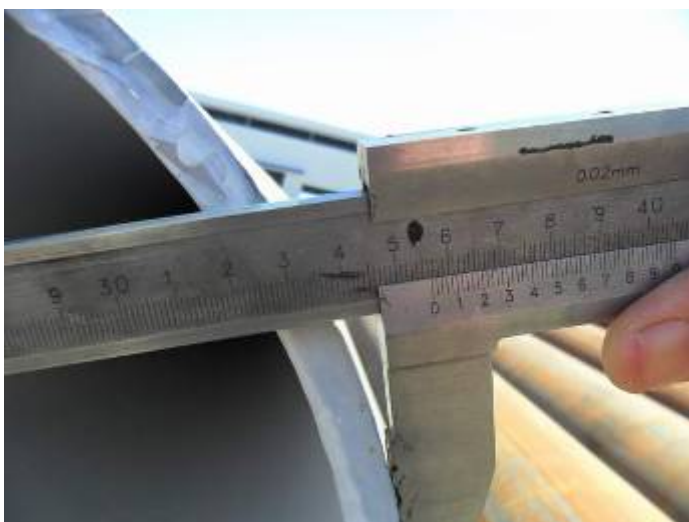
18. Outside diameter : 356.8mm

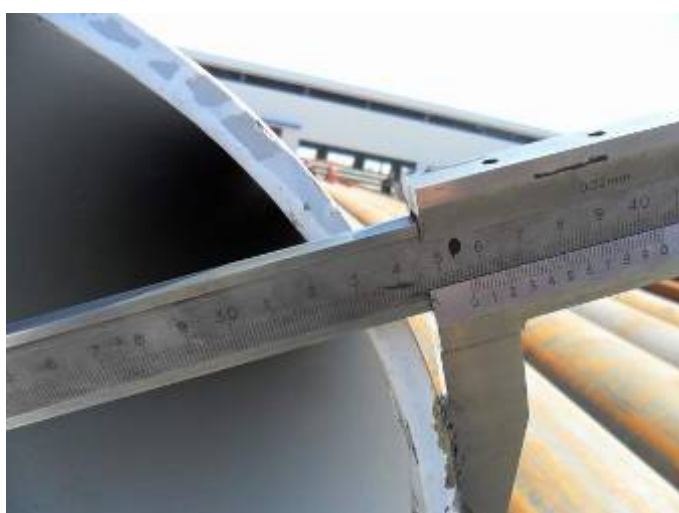
19. Outside diameter356.9

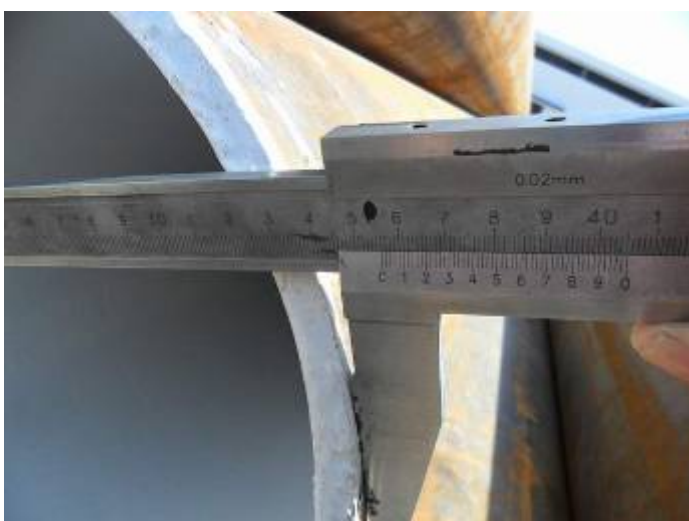
20. Outside diameter : 356.2mm

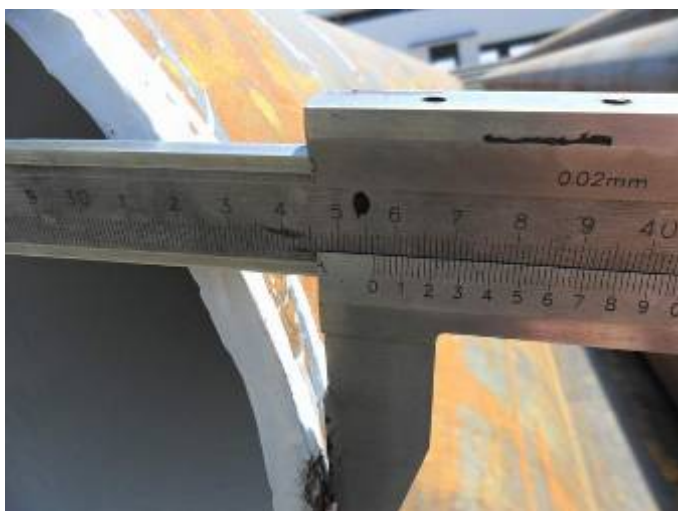
20. Outside diameter : 356.3mm

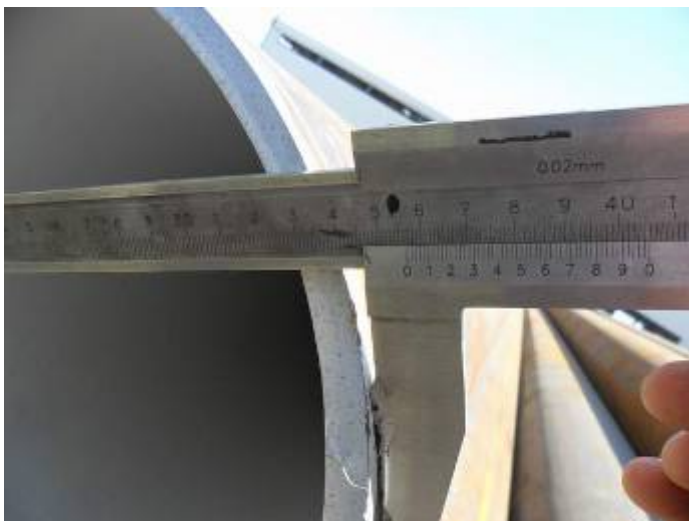
21. Outside diameter : 356.9mm

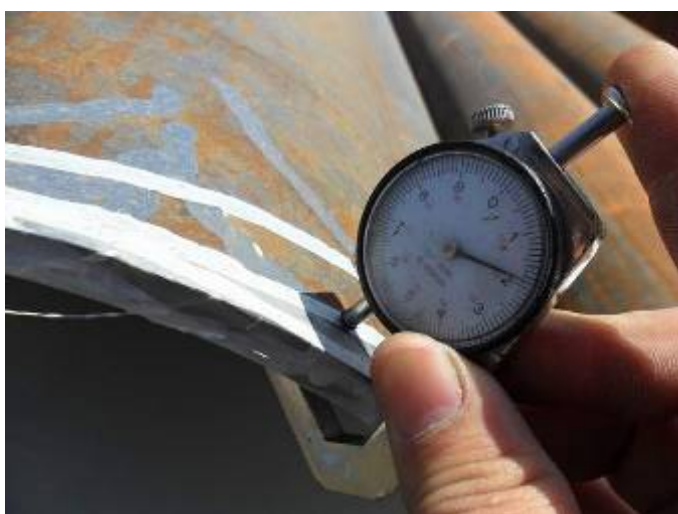
23. Wall thickness test :11.9mm

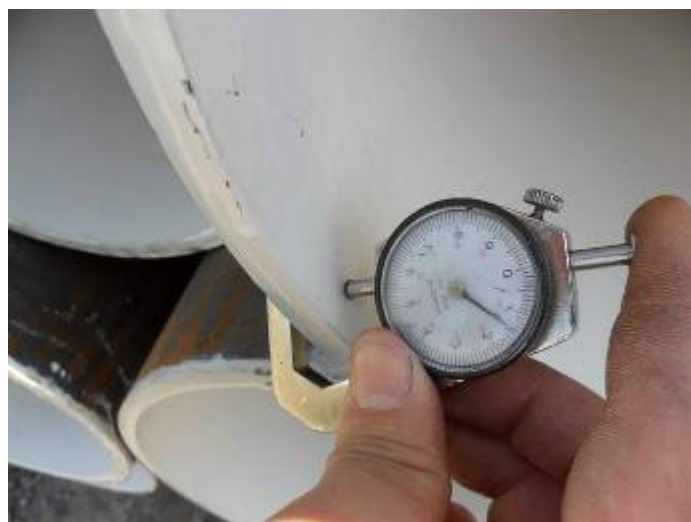
24. Wall thickness test :11.4mm

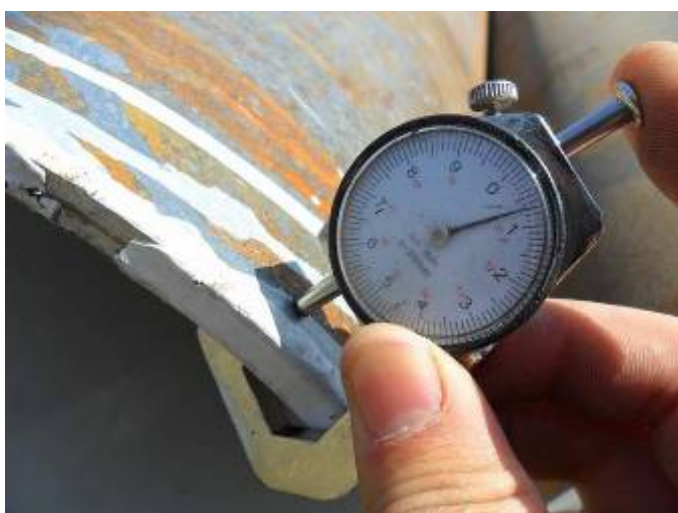
25. Wall thickness test :10.7mm

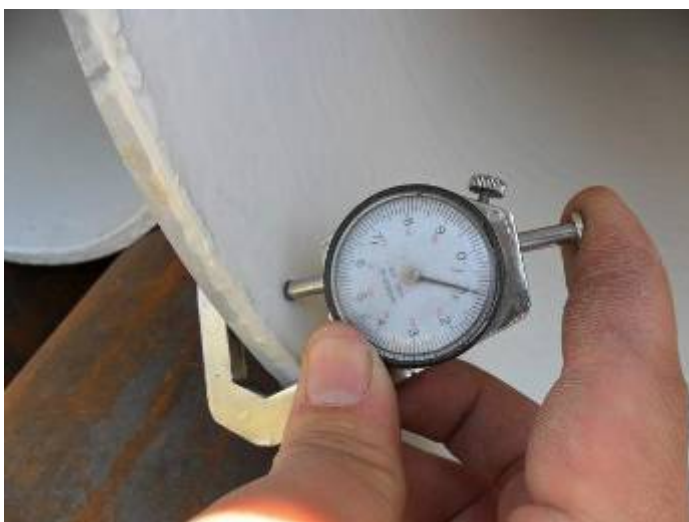
26. Wall thickness test :11mm

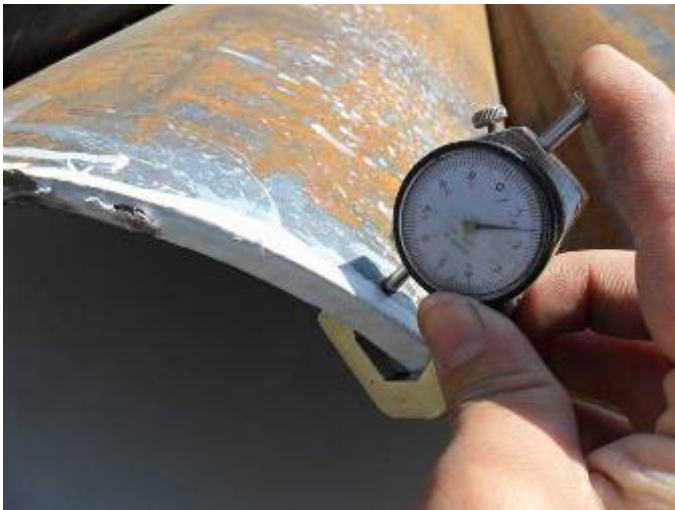
27. Wall thickness test :11.5mm

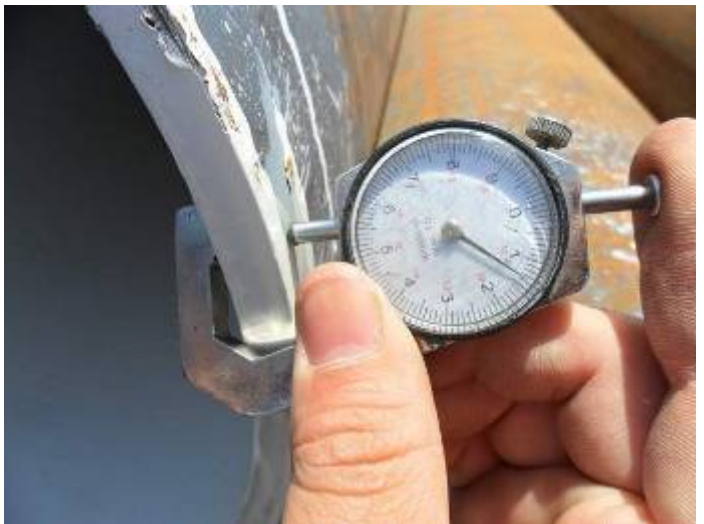
28. Wall thickness test : 11.3mm

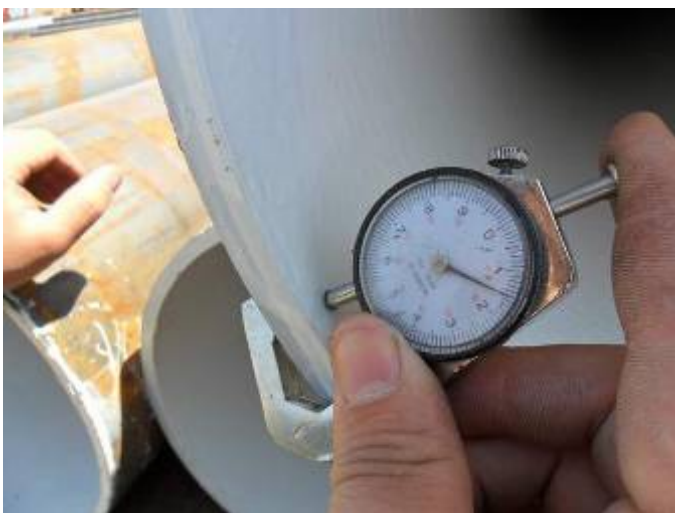
29. Wall thickness test :11.5mm

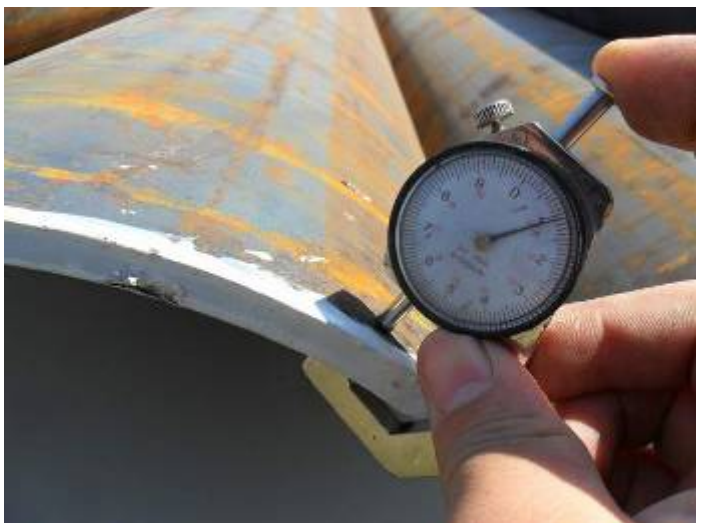
30. Wall thickness test :11.1mm

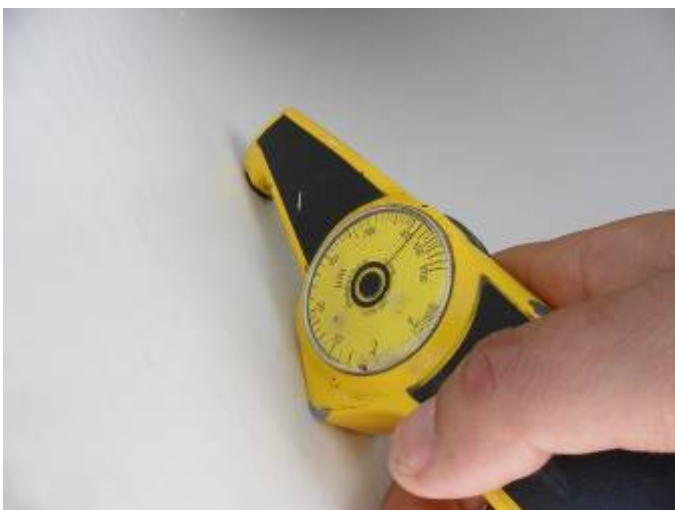
31. Epoxy resin paint thickness : 450μm

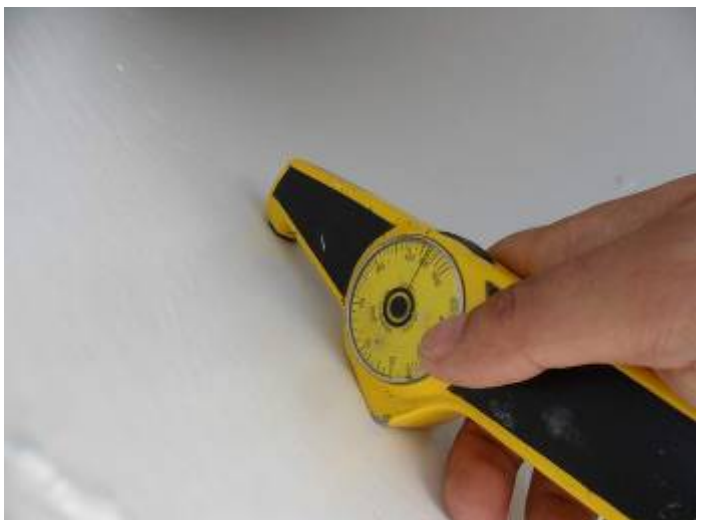
32. Epoxy resin paint thickness : 570μm

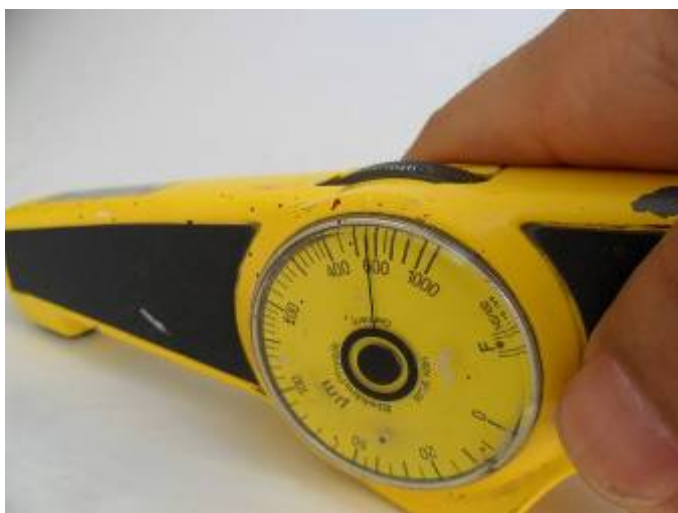
33. Epoxy resin paint thickness : 550µm

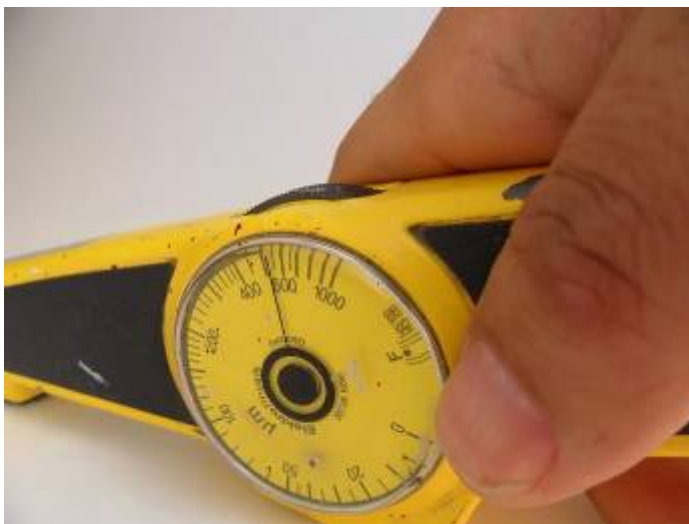
34. Epoxy resin paint thickness : 510µm

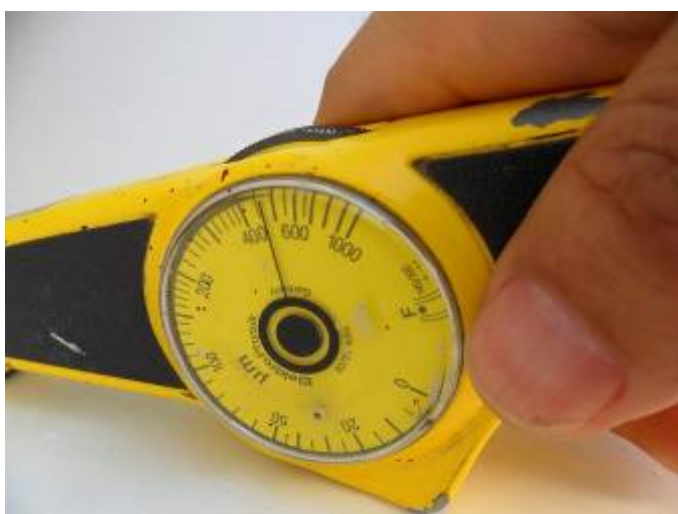
35. Epoxy resin paint thickness : 460µm

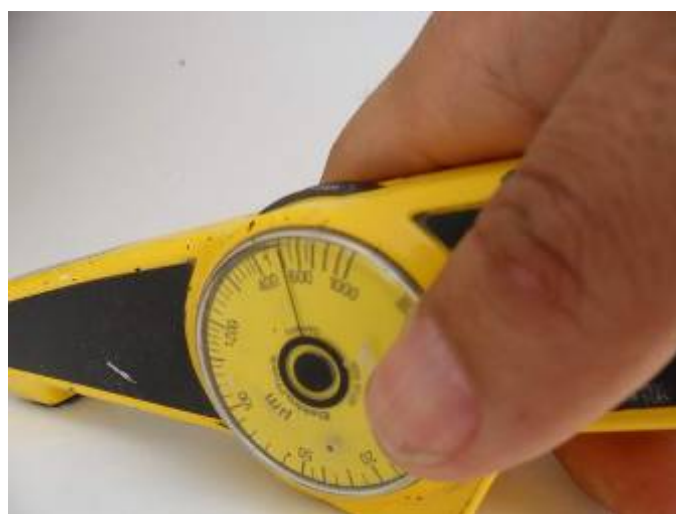
36. Epoxy resin paint thickness : 500µm

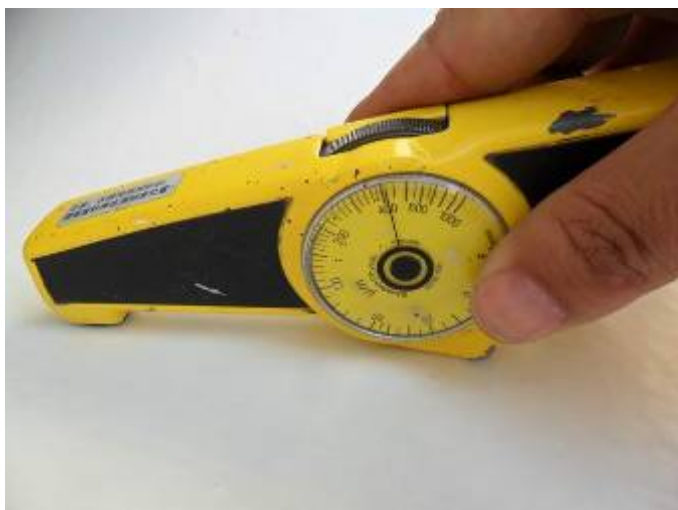
37. Epoxy resin paint thickness : 410µm

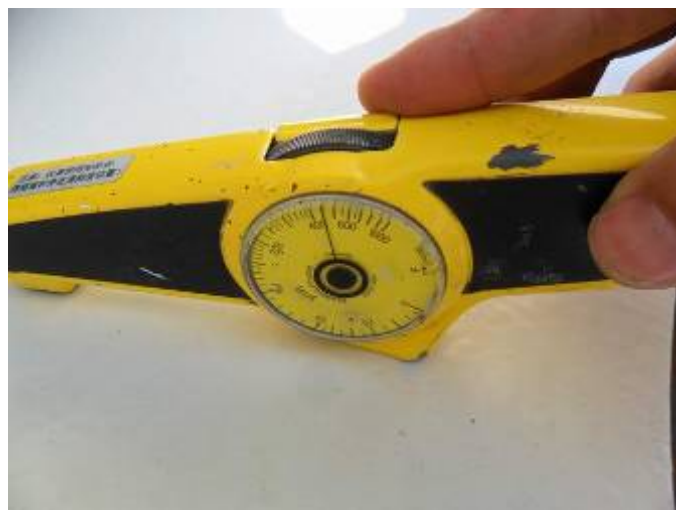
38. Epoxy resin paint thickness : 450µm
